**EVALUATION OF RAIN-EROSION-RESISTANT MATERIALS  
TO PROTECT THE HH-43B/F HELICOPTER ROTOR**

TECHNICAL REPORT SEG-TR-65-53

AUGUST 1966

SYSTEMS ENGINEERING GROUP  
RESEARCH AND TECHNOLOGY DIVISION  
AIR FORCE SYSTEMS COMMAND  
WRIGHT-PATTERSON AIR FORCE BASE, OHIO

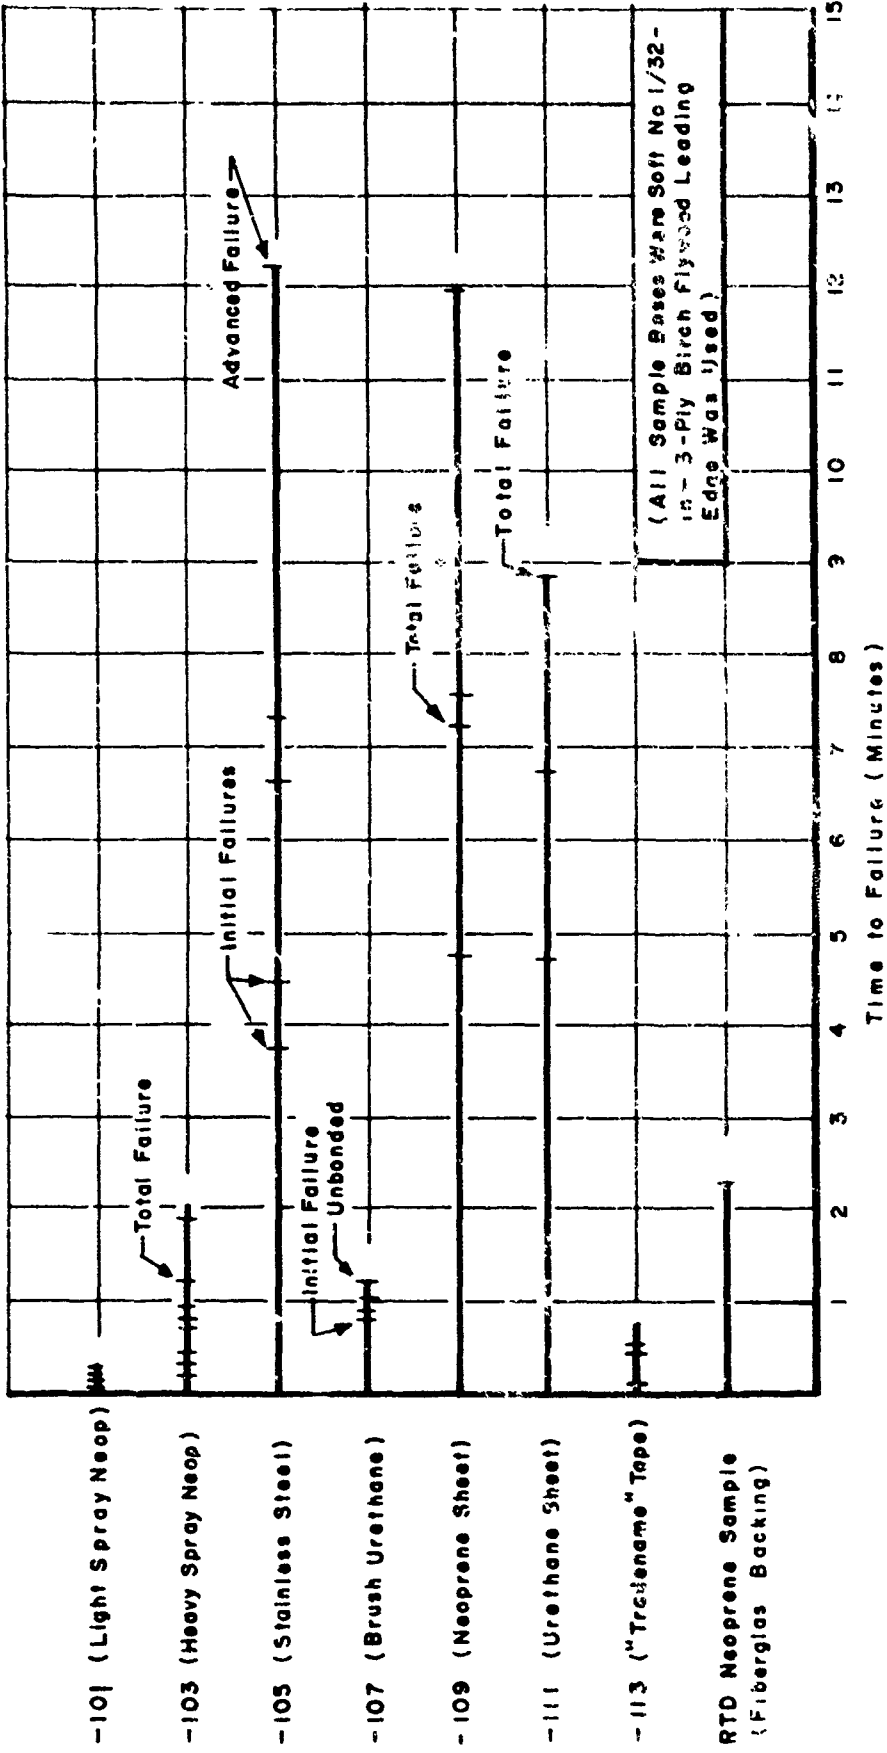
Figure 10. Time-to-Failure for Samples Tested at High Speed (500 mph)

Samples -101 through -113 (see Appendix) were tested at 733 ft/sec tip speed and the time to failure was noted. All of these materials were applied over the bare spruce blocks and the results are shown plotted in Figure 10.

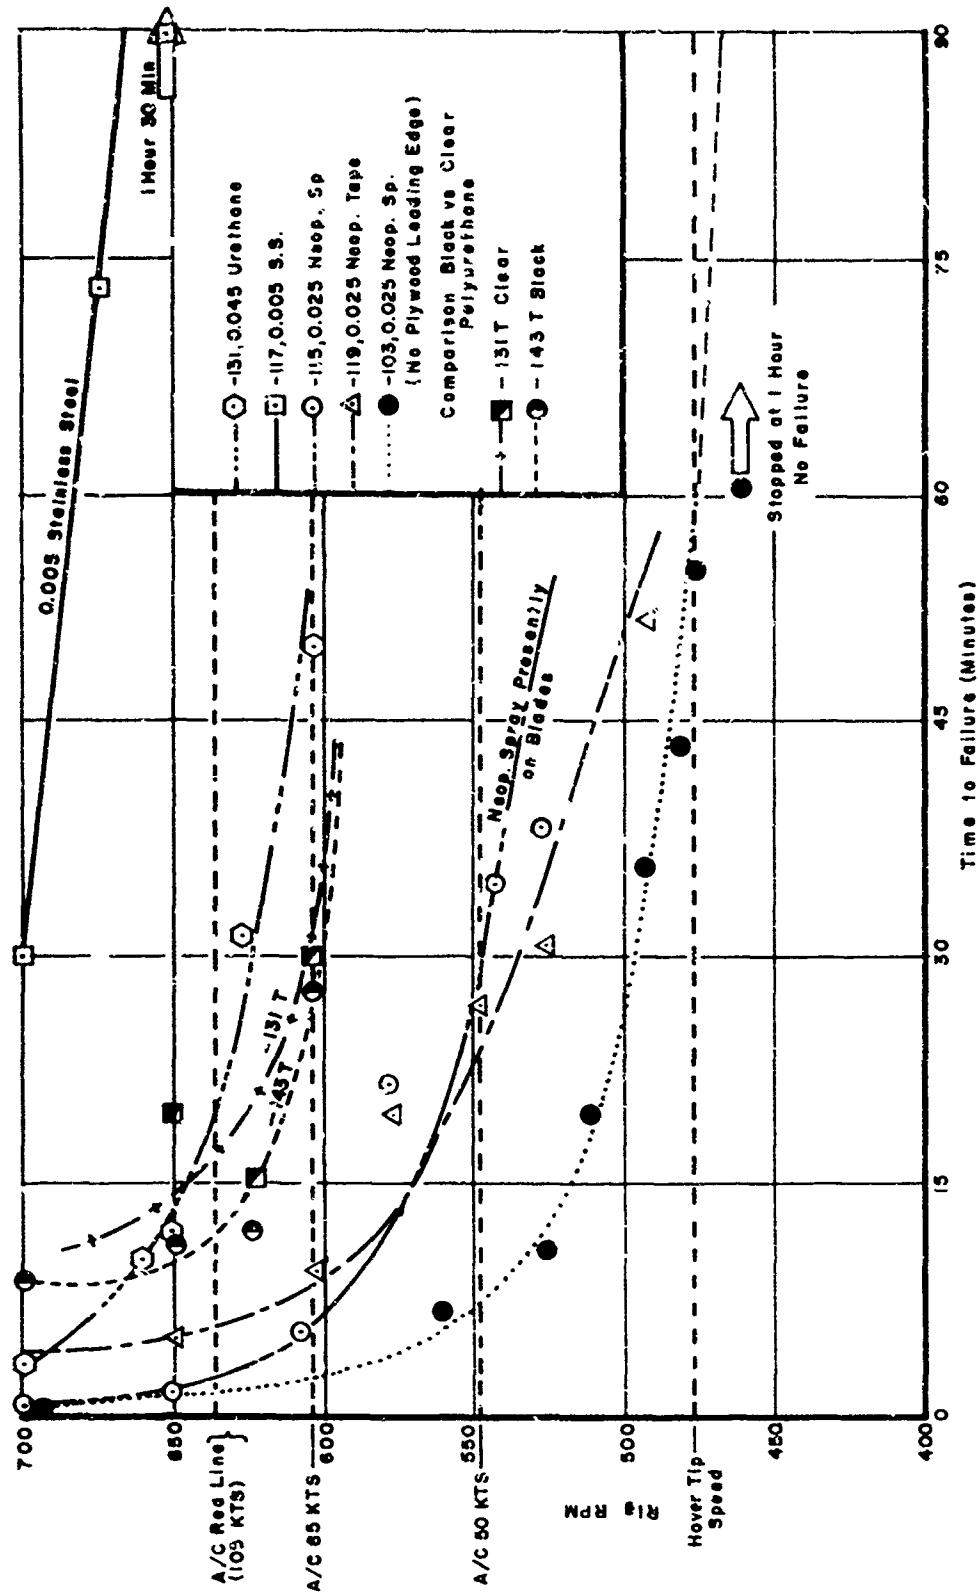
Figure 14. Time-to-Failure for Samples Tested at Varying Speeds

The significance of varying the test speed is clearly shown in Figures 14 and 15. The curve of a material which shifts to the right with increasing time-to-failure, and upward with increasing speed indicates a material which provides greater resistance to rain erosion. Results shown in Figure 15 indicate good correlation of the various neoprene samples with the exception of sample -123. Sample -123 was a composite construction of cloth impregnated with neoprene, and cannot truly be compared to pure neoprene tapes or sheets.

A significant point is that (excluding the -129 material) no material tested at hover tip speed failed after one hour of testing. Examination of Figures 14 and 15 reveals that for most of the curves a definite boundary or area exists, above which failures occur rapidly and below which the time-to-failure increases or may never fail if the speed is low enough. This might be considered analogous to the alternating load endurance limit and "run out" for metals. The failure curves are shaped very similar to classical S-N curves. Thus, use of these materials on an actual aircraft at hover flap speeds should not result in failures in a reasonable period of time. As the speed of operation increases, the time-to-failure decreases proportional to the damage done. A study of Figures 14, 15 and 21 emphasize this point very well.

Although Stainless Steel -117 (shown in Figure 17) was the best material tested, it was not recommended for this application because of its known susceptibility to sand abrasion when applied in very thin sheets (0.005 in.). Figure 14 shows that the third Stainless sample had not failed when the test was stopped after 1 hour 30 minutes.

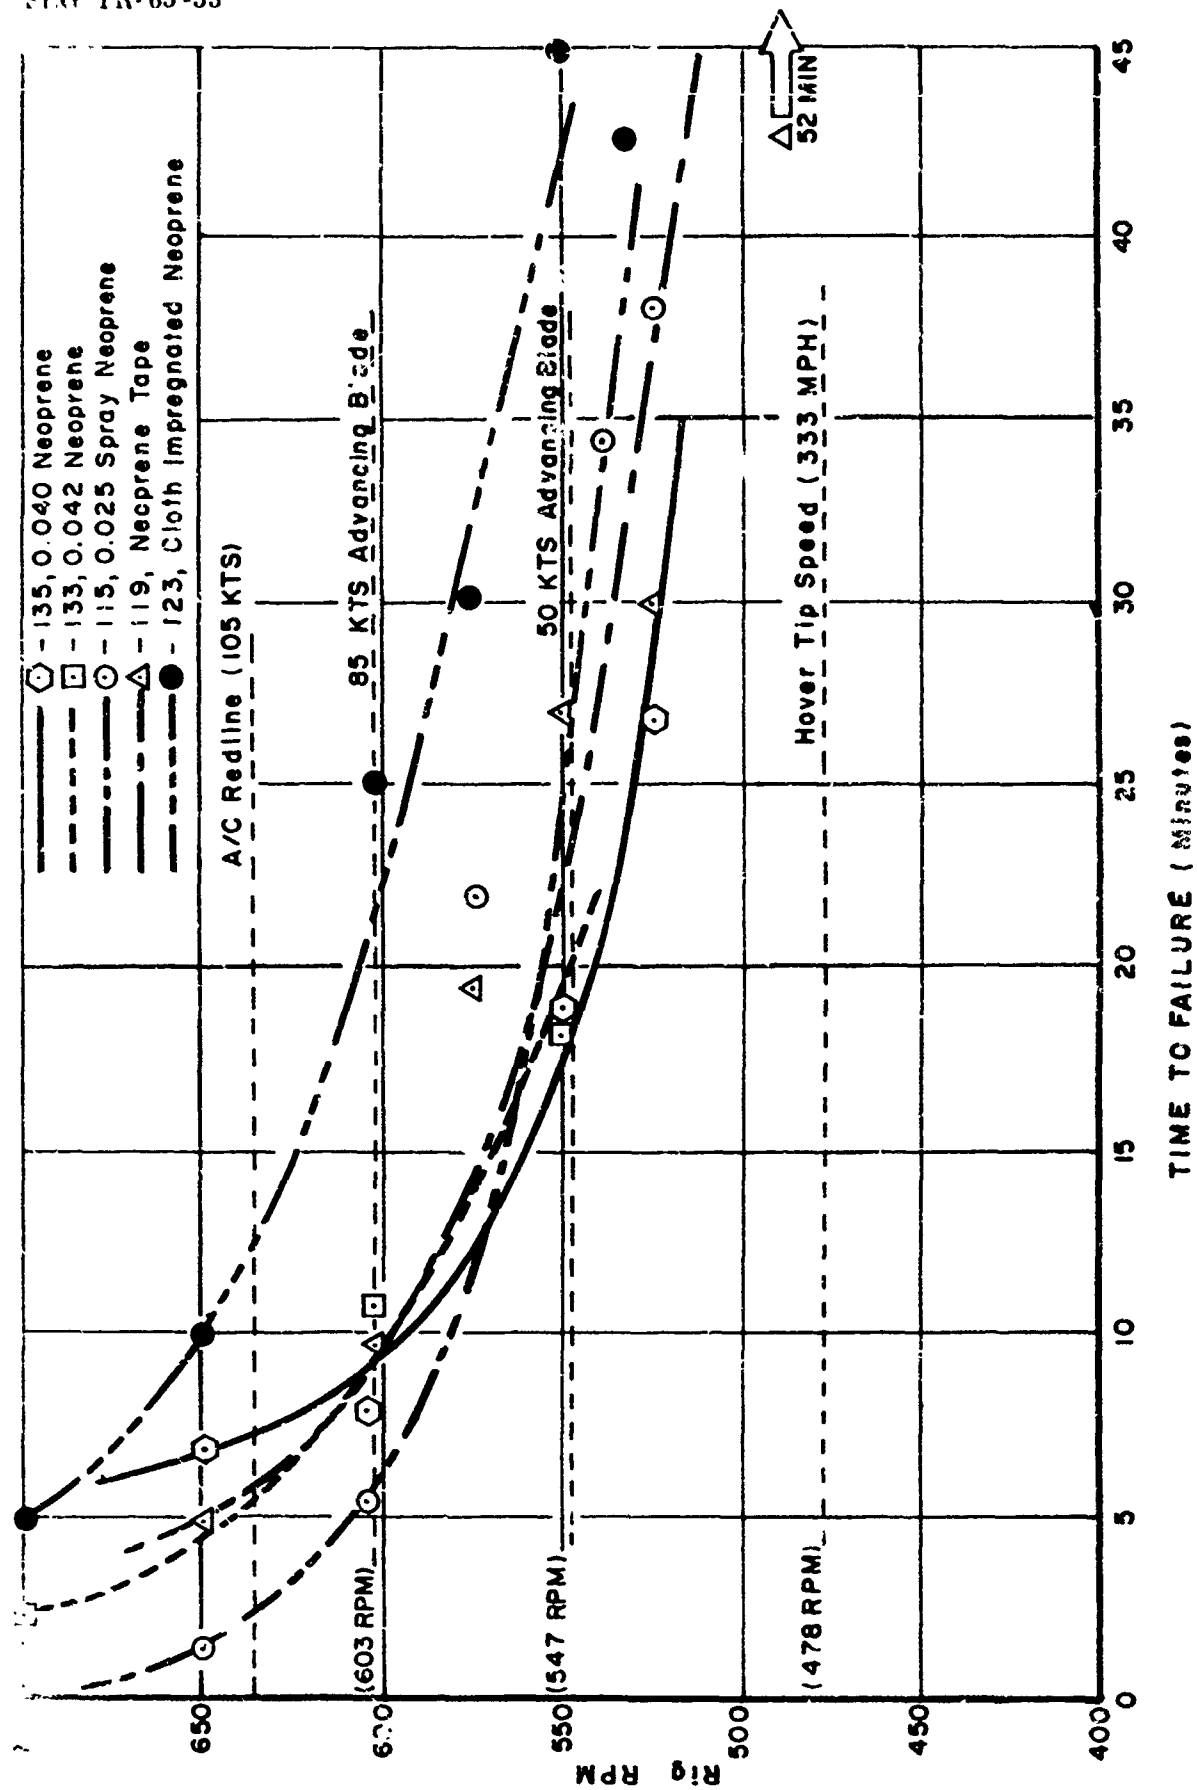
Figure 15. Comparison of Neoprene Samples Tested to Failure

The fact that some materials provide better protection at high speeds while others are better at low speeds is illustrated by Figure 15. Allowing for obvious scatter, there is a strong trend for certain materials such as the -115 material to be better at higher speeds, although the curve crosses all the others and is the worst at low speeds.

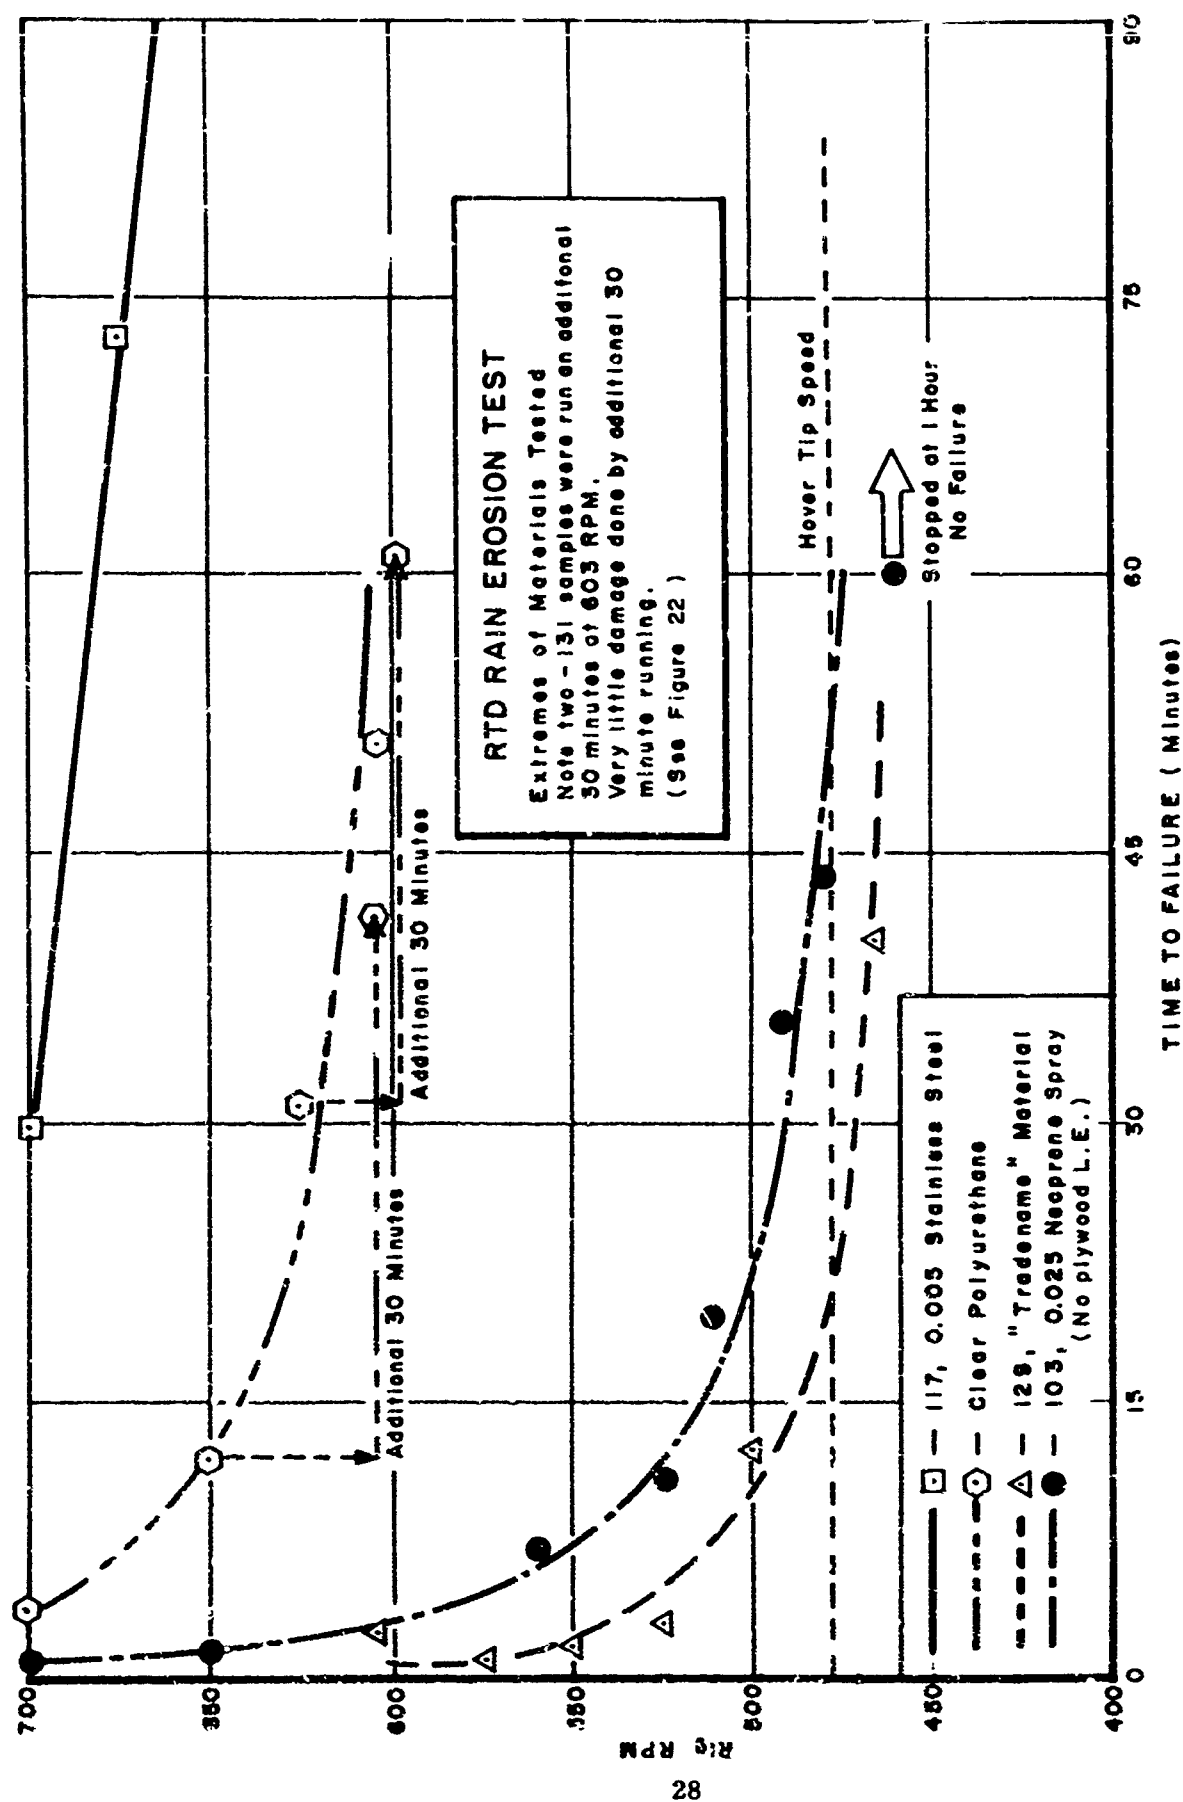
Figure 21. Extreme Values for Specific Materials Tested

Sample -129 (Figure 20) was the poorest material tested, with failures occurring below the hover flap speed as shown by Figure 21. The material was very brittle and portions of it would chip and crack off after only short periods of exposure to water.

Figure 21 shows the extremes of protection offered by the various materials tested. Depending on the speed of operation required, a choice of several materials is available. For an impact velocity of 300 mph, a neoprene material would be sufficient, for an intermediate speed of 400 mph one would select a polyurethane material and for extended operation around 500 mph, Stainless Steel would be required.
